Spray Foam: The Not So Perfect Insulation

By Stephen MacDougall, P.Eng. Brown & Beattie Ltd.

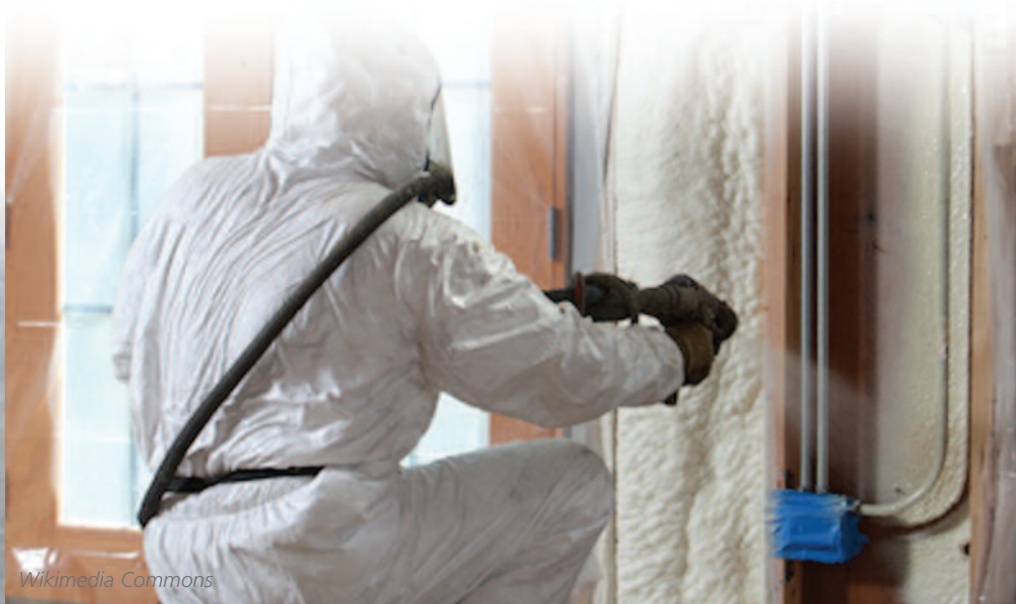
The use of spray foam insulation within flat roof assemblies without ventilation has one significant drawback however; moisture which enters the roof assembly is trapped between the insulation and roofing membrane, both of which act as vapour retarders.

The use of spray foam insulation within flat roof assemblies without ventilation has one significant drawback however; moisture which enters the roof assembly is trapped between the insulation and roofing membrane, both of which act as vapour retarders. Further, unlike a conventional roof where significant moisture within the roof assembly would typically result in visible damage to the ceiling finishes, moisture entering and collecting within a
